Structural Silicone Glazing at 50 years

Jon Kimberlain
Andrew Dunlap
Yvonne Diaz
Adrienne Bowman-Grittini

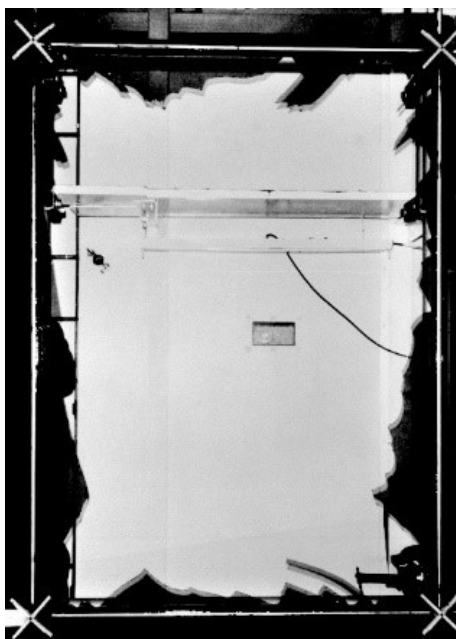
Early mock-up testing for the SH&G building provided a look into the long-term performance of this four-sided, structurally glazed system. After testing to destruction according to ASTM E330, "Standard Test Method for Structural Performance of Exterior Windows, Doors, Skylights and Curtain Walls by Uniform Static Air Pressure Difference" at 3.34 kPa positive windload, it was observed that only the central portion of the glass was destroyed (Figure 9) (Hilliard, Parise, & Peterson). The silicone sealant, in contrast, still supported the glass along the perimeter demonstrating the continued strength of the sealant after glass failure. Although cast aluminum Spiders were installed to the aluminum frame to provide additional support in the event of sealant failure, this mock-up testing revealed that they were not structurally required (Figure 10) (Hilliard, Parise, & Peterson). This initial design concept paved the way for unsupported four-sided structural silicone applications only five years later (Dow, 2019).

Figure 9. Early mock-up of four-sided structural glazed system for SH&G Building. Shards of glass are seen attached to metal frame even after glass failure. Photo courtesy of Dow.

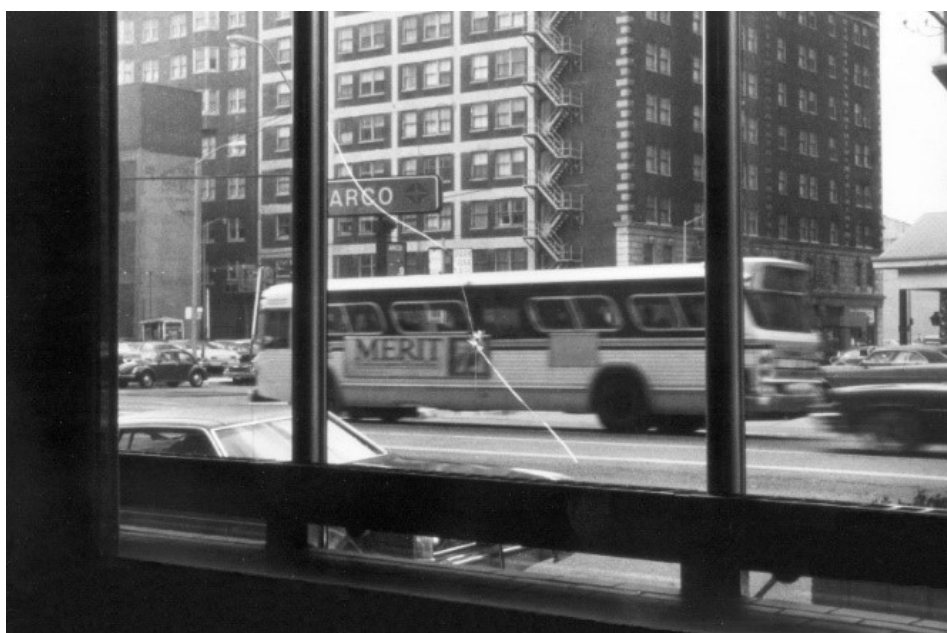
reached 40 °C in June 1988 with a record low of -29 °C in January 1984 (Current Results , 2021). Detroit experiences windspeeds and gusts from 14 to 40 kph (Winderfinder, 2021), precipitation averaging at 23 cm per year, and has had over 80 tornados since 1950 along with several tornados in the direct vicinity of the building (Figure 14) (Detroit's NPR Station, 2021) (Home Facts, 2021). The SH&G building structural silicone glazing system has stood the test of time through various weather conditions and an occasional glass breakage. In 1977 when a large wing nut fractured a lite of glass, it retained its structure for three days until a replacement lite was reglazed (Figure 15). This repair was easily completed without disturbing surrounding glass (Hilliard, Parise, & Peterson).

Figure 15. Picture of broken glass circa 1977. Photo courtesy of Dow.

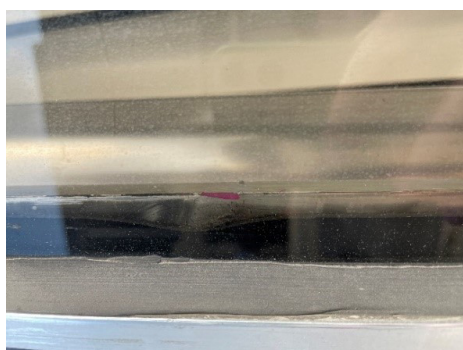
Several lites appeared to have been replaced, and the silicone applied dimension and adhesion appearance did not look to be consistent with the original workmanship nor the expected workmanship outlined in today's standard (ASTM C1401-14). Figure 17 shows one such example where an area of sealant was not fully adhered to the glass. The area may have been a result of insufficient fill so that an air void formed during the application or lack of cleaning where separation may have occurred over time. Figure 18 illustrates a smaller dimension of sealant than typical of the original installation; however, based on the above design assumptions, the bite would approach a dimension that would be adequate today. Figure 19 further illustrates what appeared to be significant smearing of a sealant, perhaps indicative of poor attention to detail as the sealant was installed during glazing replacement.

Figure 17. Section of sealant appearing to lack full adhesion – July 2021. Courtesy of Dow.

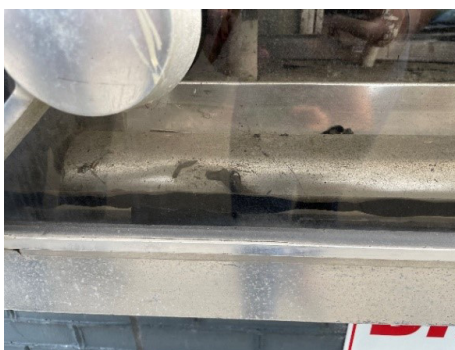
Figure 18. Smaller Bite dimension compared to original intent – July 2021. Courtesy of Dow.

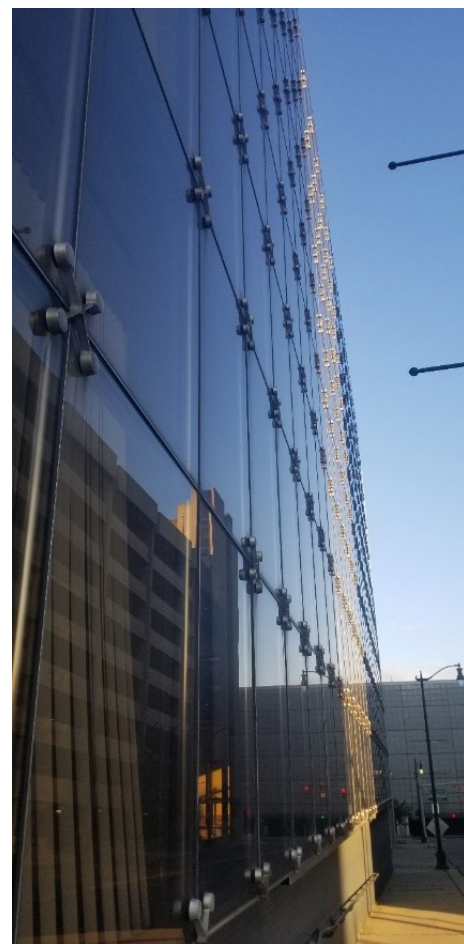
A July 2021 inspection of the building found several of the Spider fittings missing or loose (Figure 16). The Spiders at the top of the building were missing, and it was speculated they were removed for roofing activity and never replaced. Also, some of the rubber pads that protect the glass from the Spiders were missing from the cup ends of the fittings and others appeared to have been permanently deformed resulting in no contact between the rubber pad and glass.

Figure 16. Missing Spider fitting shown on first row of glass lites – July 2021, Courtesy of SmithGroup.

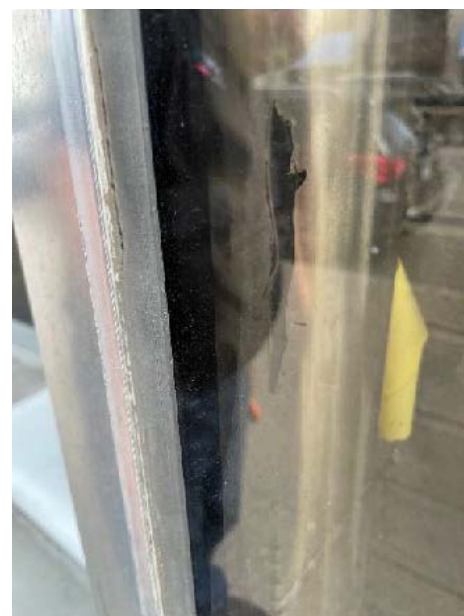
Figure 19. Appearance of smeared sealant – July 2021. Courtesy of Dow.

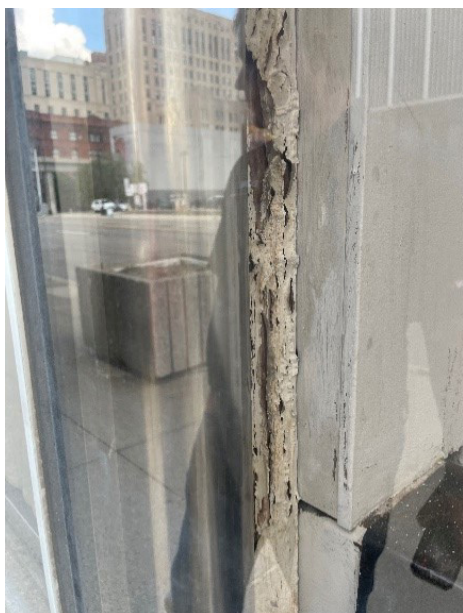
A final observation on the condition of some of the interior materials was interesting considering environmental exposure for over 50 years. Coating on a wood stud, shown in Figure 20, degraded to the point of cracking and peeling due to UV exposure. Despite the unknown age of the coating, this observation provides a noticeable contrast in performance and reinforces the inherent durability of silicone sealant when exposed to UV light.

Figure 20. Degradation on interior acrylic coating that receives significant UV exposure. Courtesy of Dow.
