Historic glazing in existing buildings using the example of Dresden Trachau

Franziska Rehde, Institute of Building Construction, Technische Universität Dresden, August-Bebel-Straße 30, 01219 Dresden, Germany

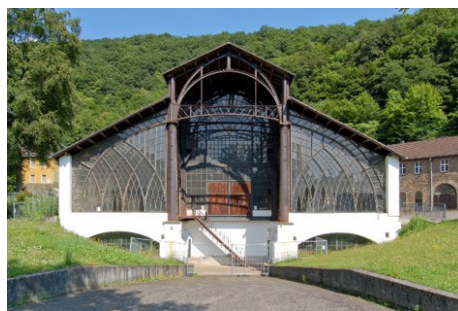
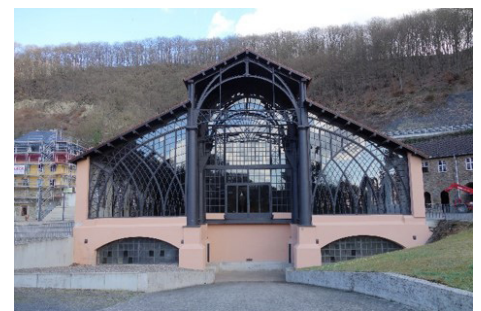
Figure 1 Sayner Hütte before renovation with historic windows (a) and afterwards with Floatglass (b).

The glass itself is thus a testimony to the materiality of its time. In terms of production technology, both the surfaces of the various manufacturing processes and the material composition itself differ. Nowadays, historical glasspanes and windows are often replaced. The reason for replacement is that glass is a ubiquitous product that is available in abundance and at low cost. Currently, there are no principals for identifying glass from the industrialisation period and assign it to the different manufacturing techniques used in the past. Glass from the industrialisation period has an undulating structure and optical disturbances such as bubbles. However, nowadays this is interpreted more as a defect than as a testimony to the technical progress of the time. Historical glasspanes and windows are often replaced by new float glass with plastic frames. However, this leads to a loss of authenticity of historic buildings and inevitably to a destruction of testimonies to the history of building technology (see Figure 1).

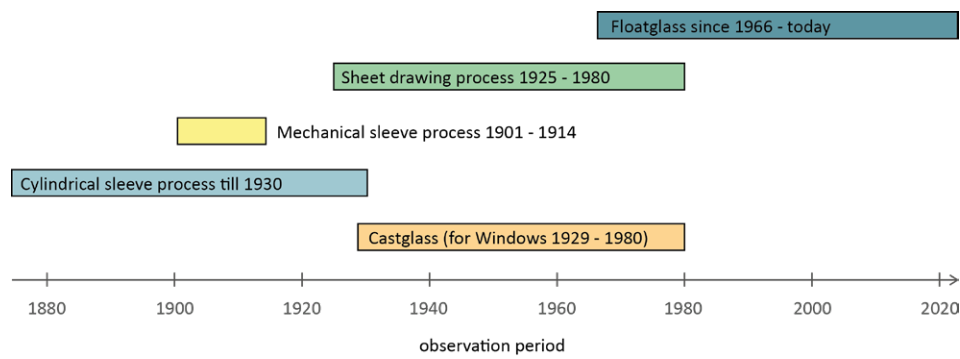
Figure 3 Chronological classification of the manufacturing process of flat glass in Germany.

Table glass was produced exclusively by the cylindric blowing process until the introduction of the first table drawing process in Germany. Most of the processes were invented but earlier in other countries. In 1924, the first glassworks in Germany began producing drawn glass using the Fourcault process. By the end of 1929, the production of hand-blown flat glass had been completely vanished in Germany. [8] Following, sheet glass was produced by the cylindric blowing process until 1924. In the period from 1924 to 1929 sheet glass products were mouth-drawn and machine-drawn. From 1930 on, sheet glass products were produced by the drawing process only, see Figure 3.

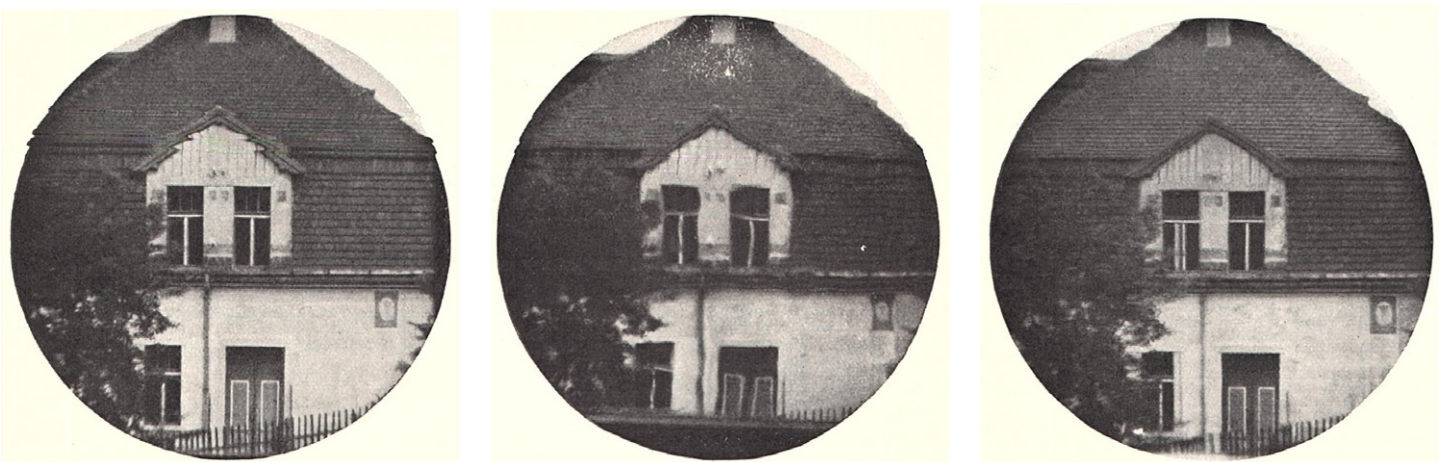
Figure 4 Views through a window with a) no window pane b) hand-blown glass and c) a pane of drawn glass (using the Fourcault method).

Figure 4 shows the differences between a no-window pane (a), the blowing process and the drawing process. With hand-blown glass (b), the wavy stripes are clearly visible. Originally straight lines are shown wavy through the glass. With drawn glass (c) the waviness relativises and is hardly perceptible, the lines remain straight. Thus, one might think that this could be a float glass pane. The difference is that a pane of glass using the Fourcault process is much less reflective than a pane using the float process.

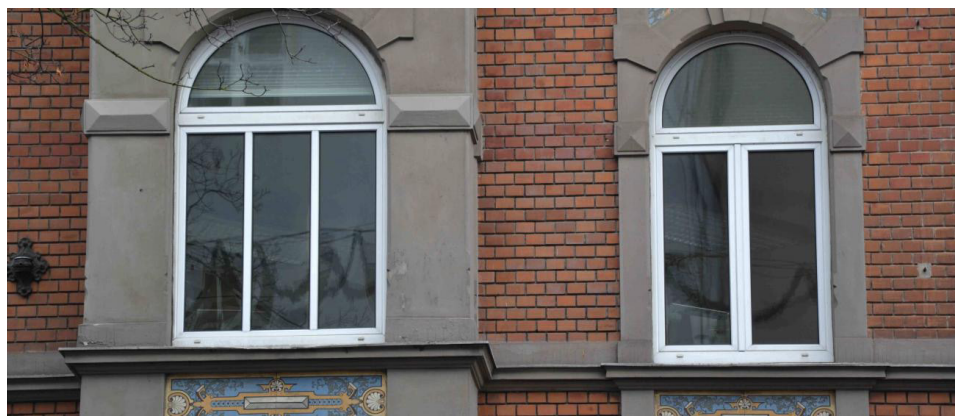
Figure 5 Plastic window frames in old buildings.

The use of modern window profiles also raises the problem that they are designed for large window sashes of the modern era. This results in large window profiles and frames. If the division of a historical window is reproduced with modern window profiles, the glass areas are significantly reduced. [9] Figure 5 shows two plastic windows in an old building. The window on the left demonstrates a window in which the forend of the once three-light window is only applied to the window pane as a thin profile. The right image demonstrates how wide the surrounding window frame and the stop of both sashes are compared to historic window construction. Furthermore, skylights in historical gables windows were not permanently glazed. [9] In addition, the historical window division is often only present as an ornament in modern windows. [10]

to insulating glass. Moreover, this insulating glass shown in Figure 5 can be recognised by the metal spacers.

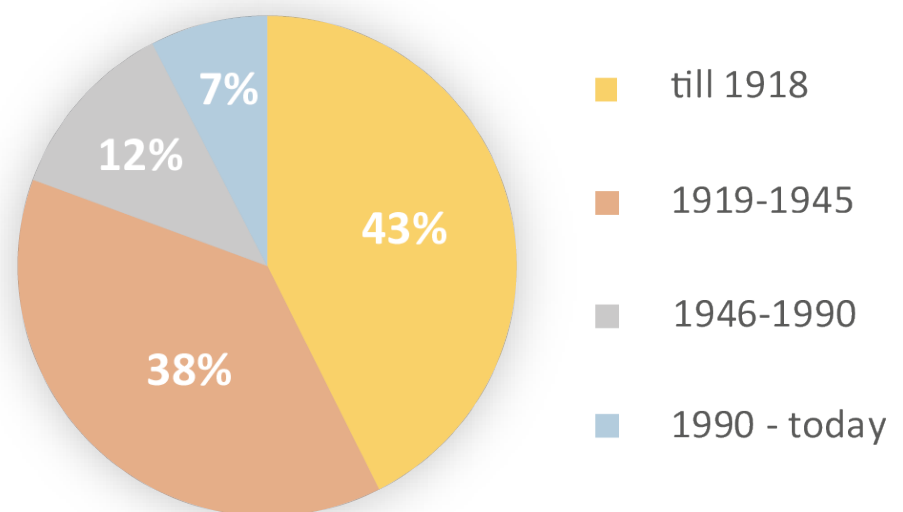
Figure 7 Classification of buildings according to year groups.

After research and visual inspection, the area is further limited to a part in the south-east of Trachau. The aim was to be able to estimate possible glass and constructions to be expected for the subsequent inventory survey in Trachau. In the south-east of the survey area, a large number of historic windows were to be expected after a walk-through. Due to the aforementioned significant change in the manufacturing methods of glass panes in the 1920s, it was of high interest to look specifically at the buildings from this period in order to obtain the highest possible density of different types of drawn glass, see Figure 7. The analysis of the district catalogue revealed that approximately 80 % of the buildings were built before 1945.

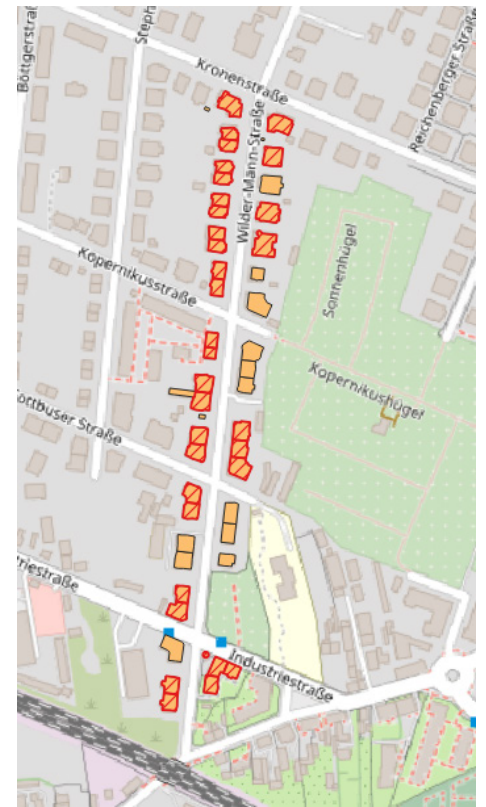
Figure 8 Buildings investigated of the "Wilder-Mann-Straße" in Dresden.

A total of 45 buildings on "Wilder Mann Straße" were examined for possible window constructions and their optical features in the style of high modernism and measured manually by hand, see Figure 8. For each building, the glass, the glass construction, the frames, the material and geometry were documented in detail with the help of a recording sheet. A total of 2178 windows were recorded, documented and evaluated.
