GLASS PERFORMANCE DAYS 2025

INVISIBLE DANGER: SAFEGUARDING GLASS FROM THE RISKS OF NICKEL SULFIDE

Presented By: Juan Pablo Martínez
Facades Production Manager
Tecnoglass Inc & ES
Email: juan@tecnoglass.com

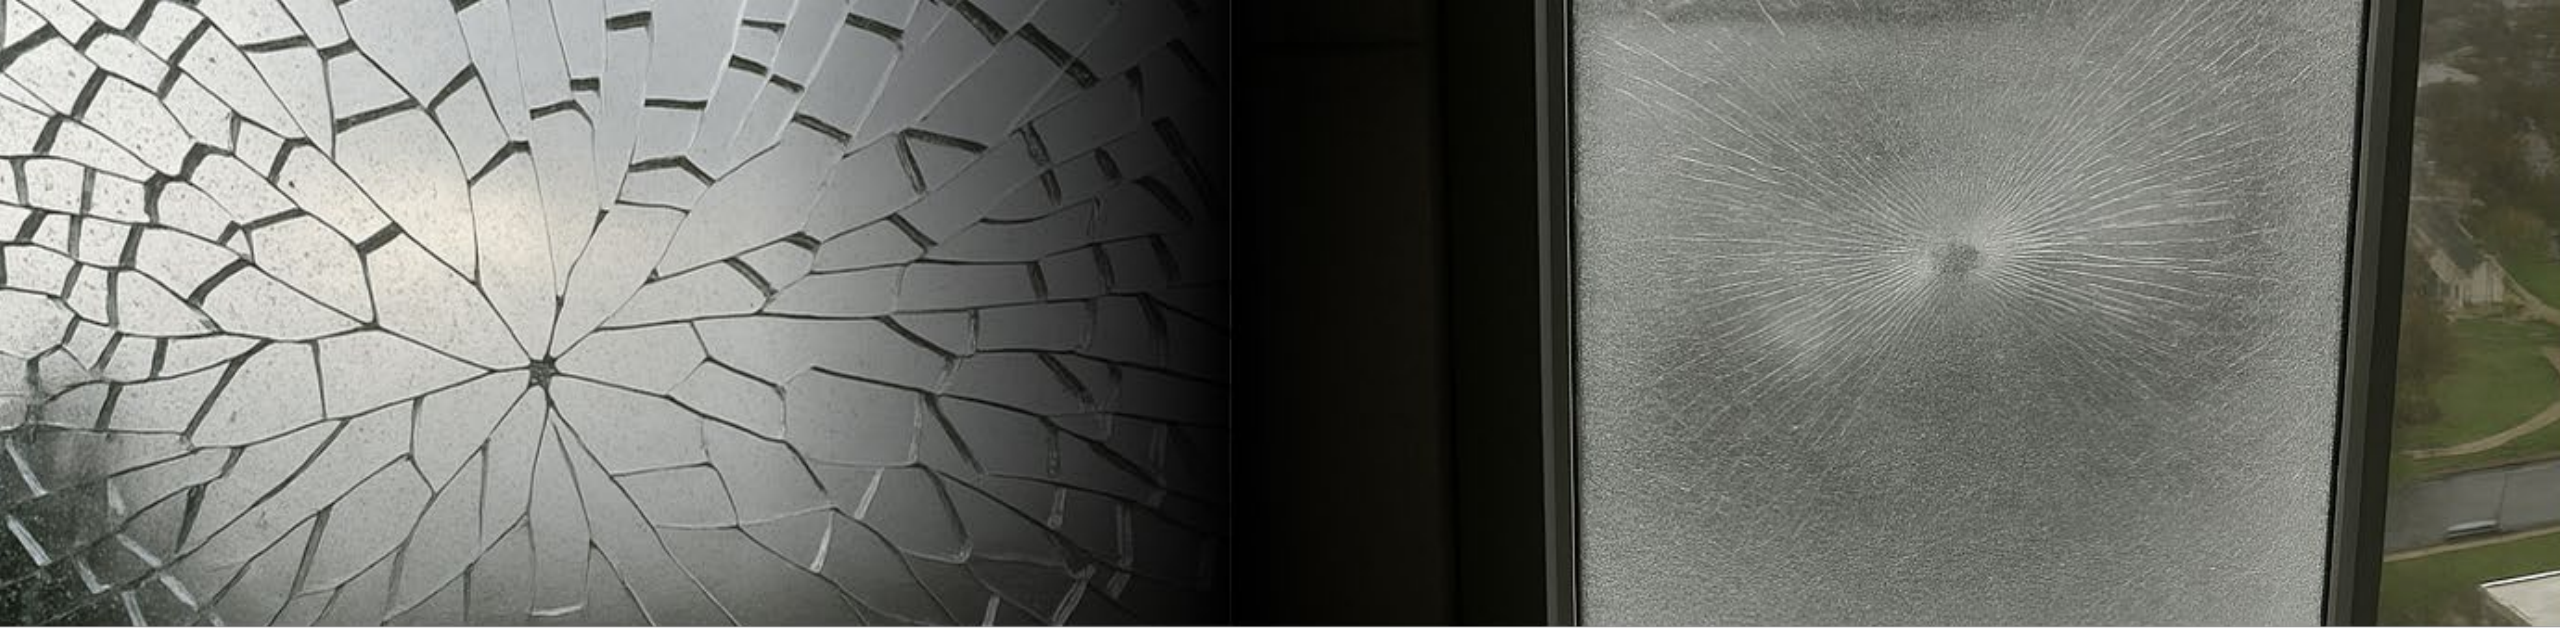
The Risk of Spontaneous Breakage

- Breakage happens with no external force
- Common signs:
 - Fracture starts from center
 - “Butterfly” or “figure-eight” fracture pattern
 - Failure may occur months/years after installation

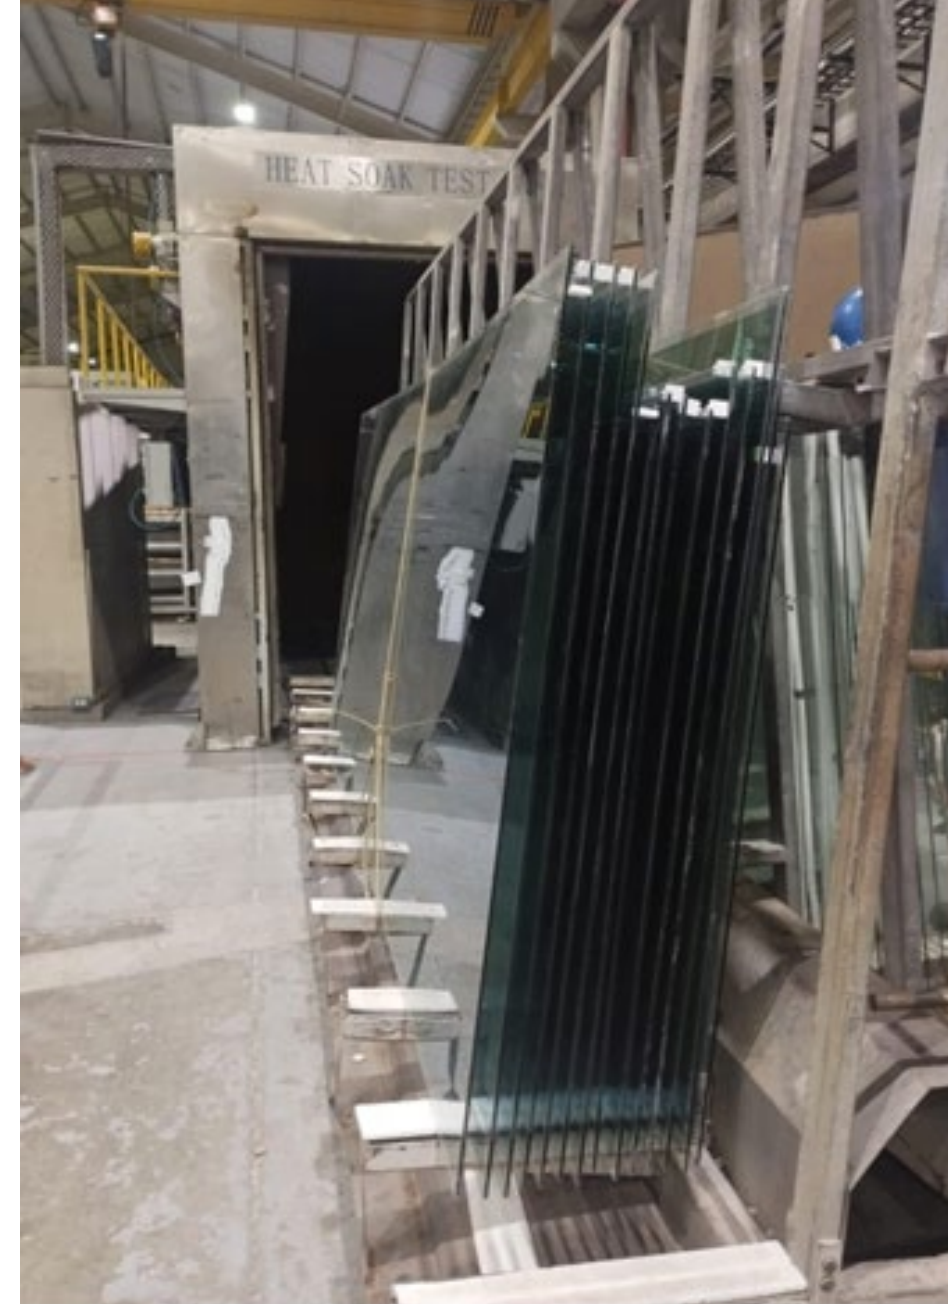
Detection Methods Overview

- NiS is microscopic — not visible during inspection
- Key detection methods:
 - Heat Soak Test (HST)
 - Thermal Imaging

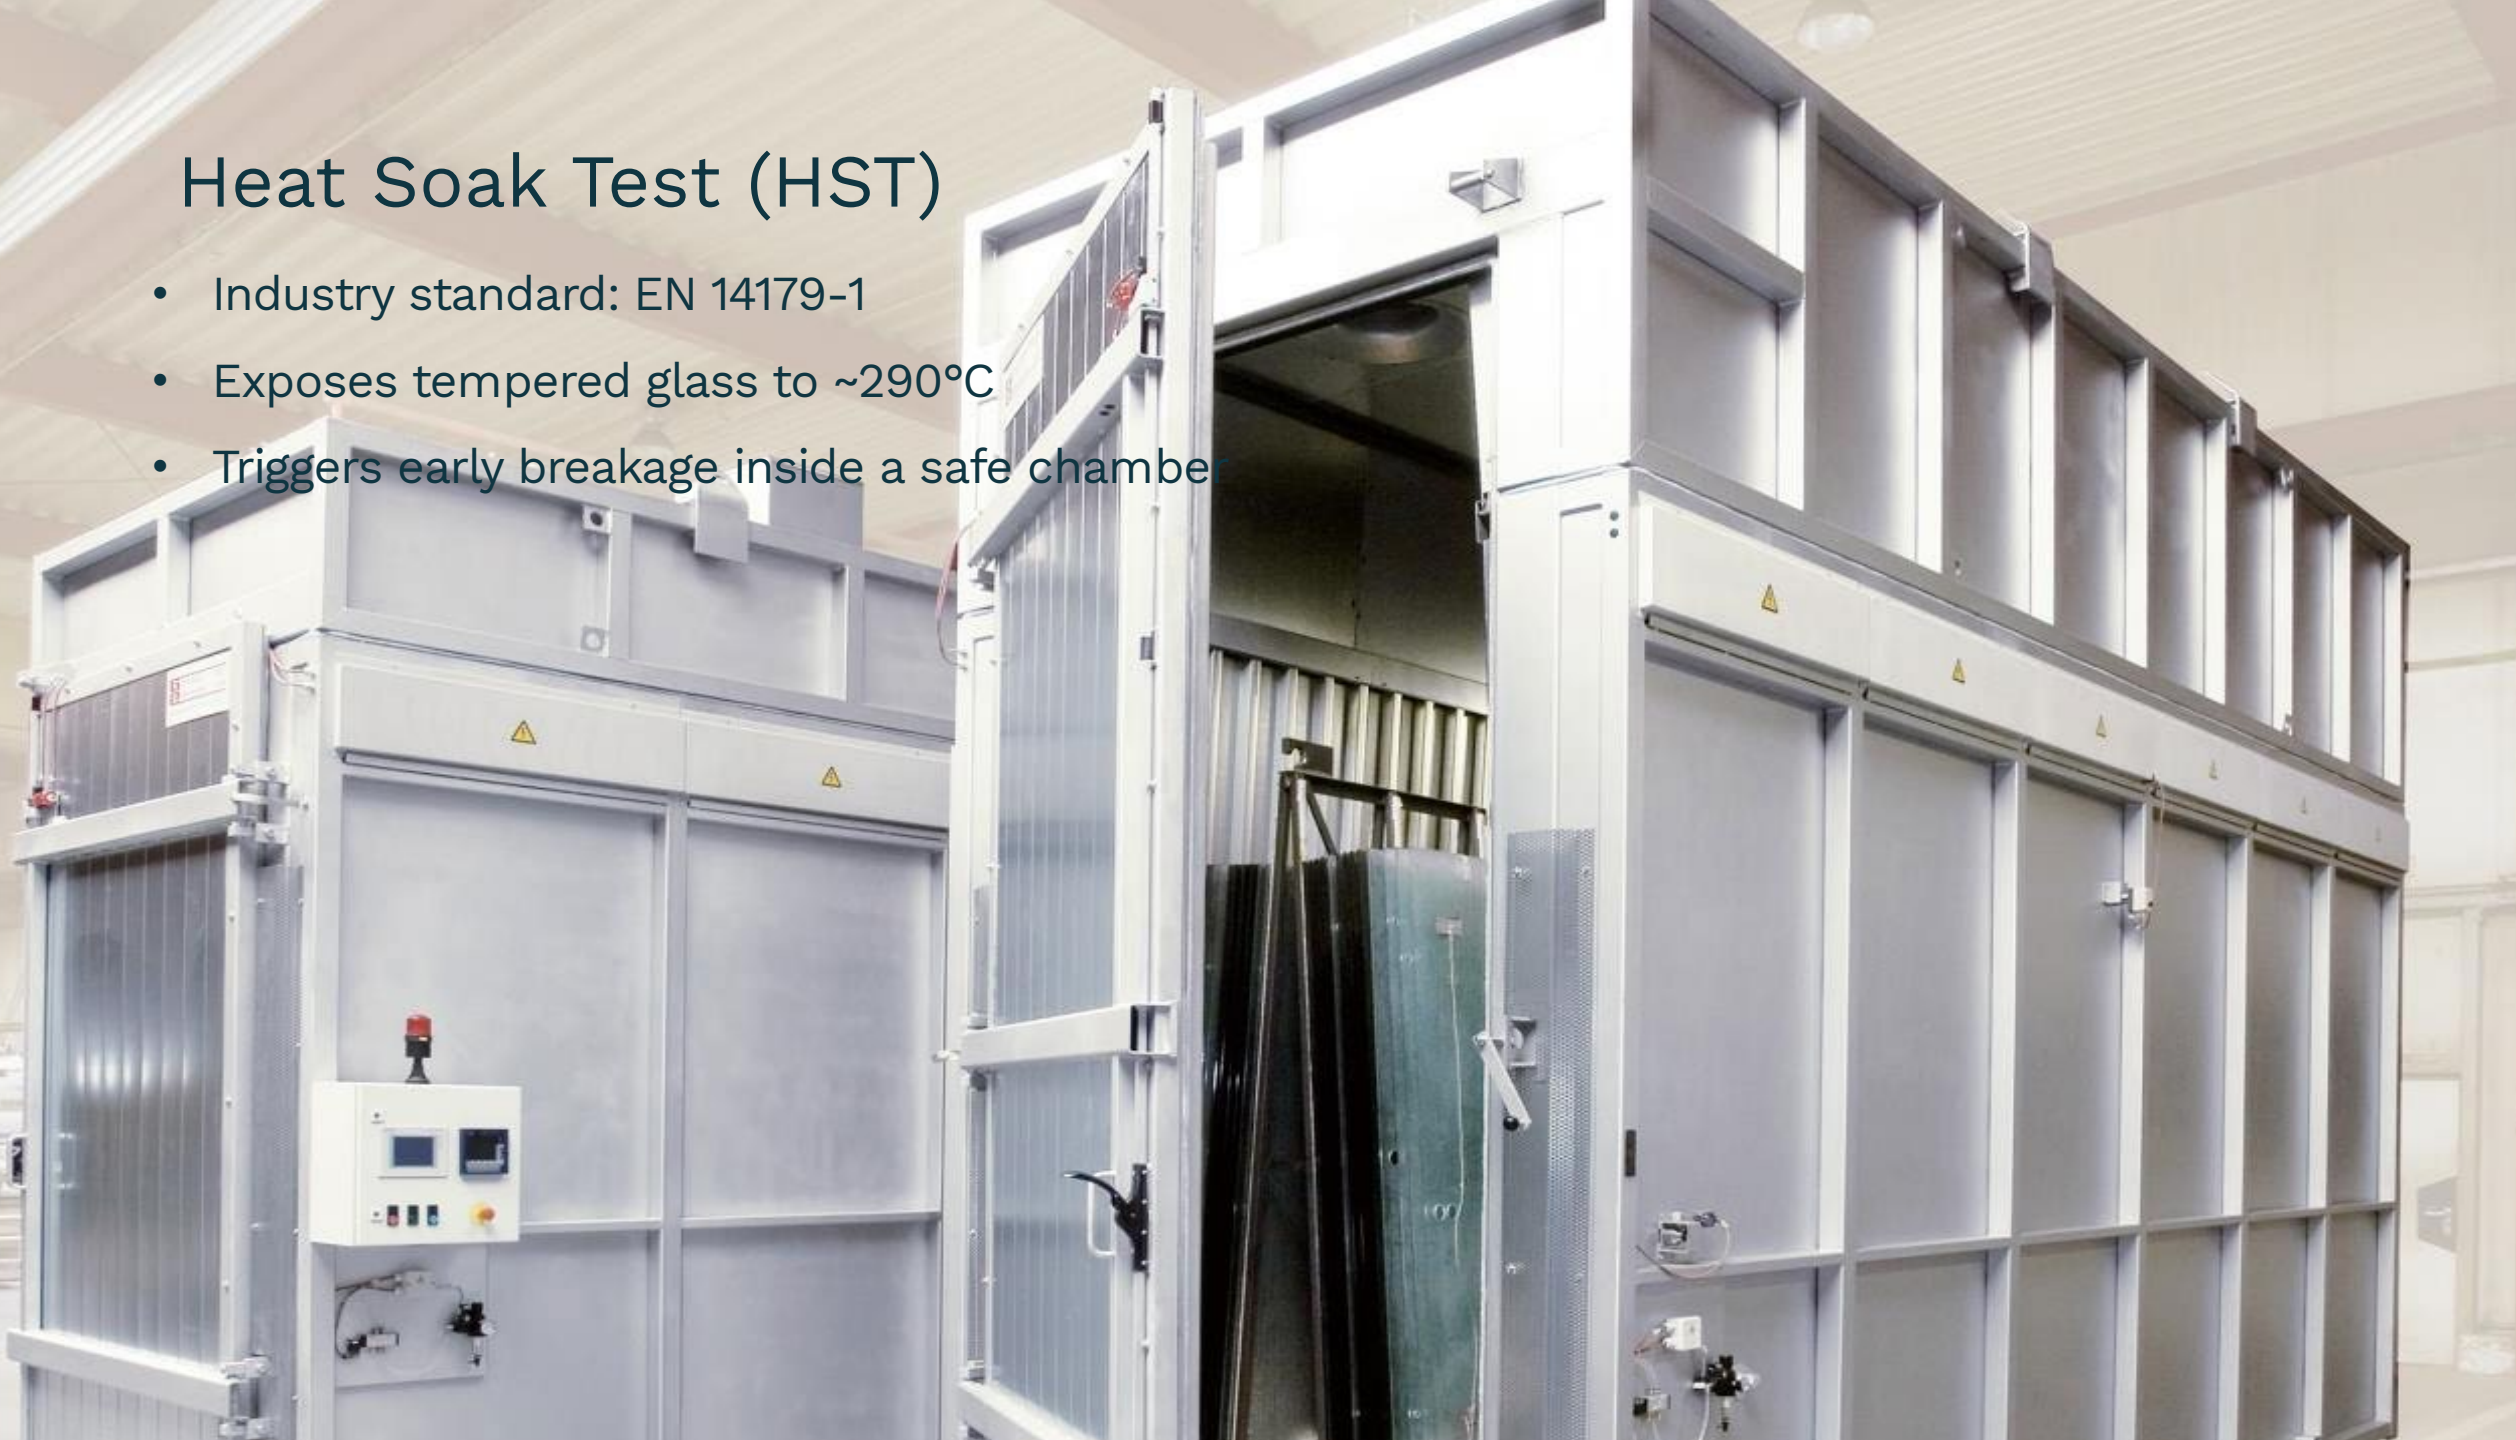
Heat Soak Test (HST)

- Industry standard: EN 14179-1
- Exposes tempered glass to $\sim 290^{\circ}\text{C}$
- Triggers early breakage inside a safe chamber

Limitations of the HST

- Doesn't catch inclusions $<50\mu\text{m}$
- Some NiS inclusions take longer to expand
- Residual risk: 5–10%
- Expensive and not adopted by all manufacturers
