Conclusions from Defects on Glass Façades

Barbara Siebert

Abstract

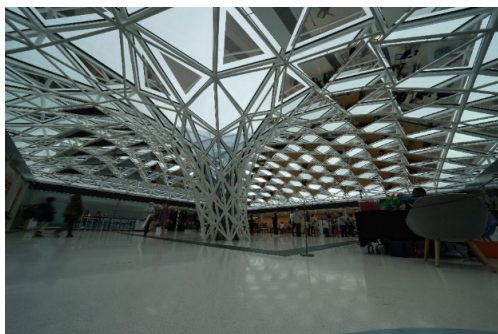
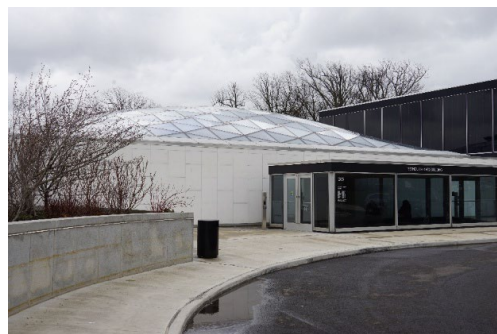
Fig. 1: Glass Roof in the AKG Art Museum, Buffalo, USA.

Nowadays built glass constructions are becoming more and more sophisticated and transparent. For these iconic projects like the glass-roof in Buffalo in Fig. 1, it is general practice that specialised designers from the glass and facade sector are consulted during the planning phases in order to obtain planning security.

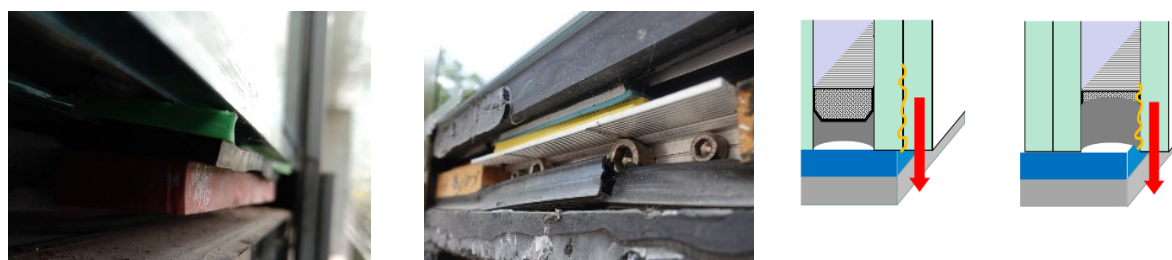
Fig. 6: Setting blocks, not properly installed.

In reality, blocks are often not in the right place, have slipped inwards so that either the outer pane of the laminated safety glass slides down on the PVB film or the outer glass pane slides along the edge seal. "Slippage" of up to 10 mm have been observed in some investigations.

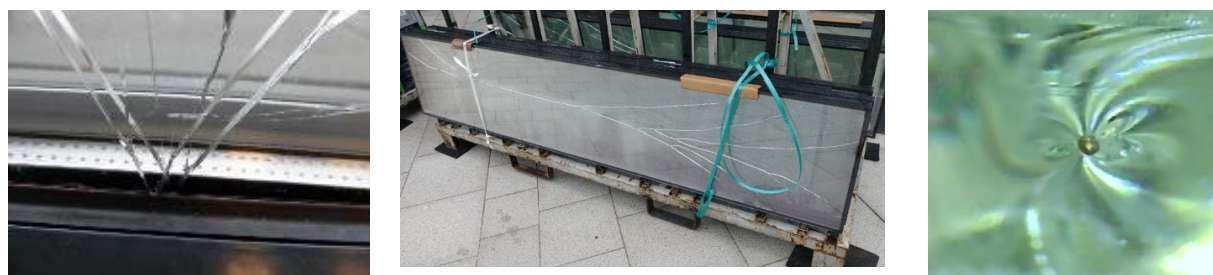
Fig. 9: thermal breakage / climatic load breakage IGU / Spontaneous failure nickel sulphide inclusion.

- Thermal breakage of float glass due to partial shading or additional heat source through absorption
- Climatic load breakage occurred due to encapsulated glass expanding in the cavity
- Spontaneous failure due to nickel sulphide inclusions in tempered glass
- Mechanical damage, insufficient edge trimming...

The first two breakages can be avoided by doing a special stress analysis or sufficient static calculation, the risk of nickel sulphide failure by heat soaking or alternative glass products.

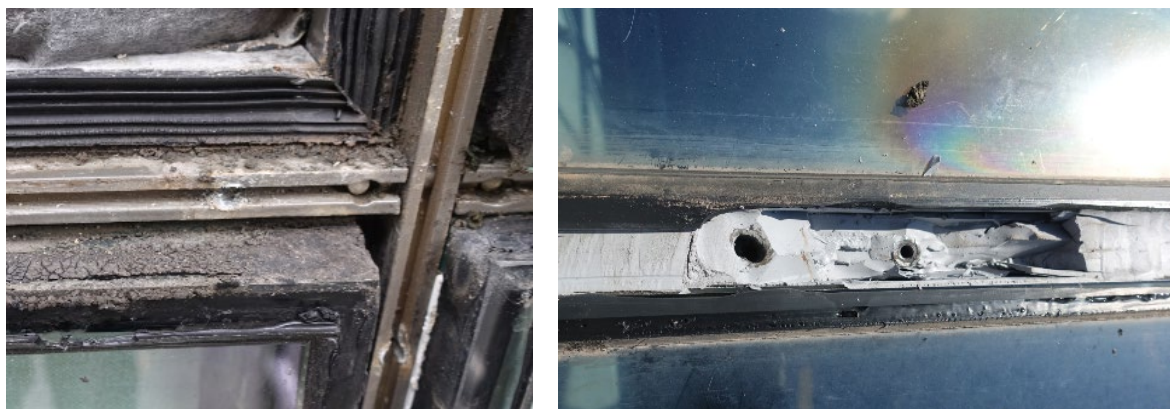
Fig. 10: Crossing point with blocked inner sealing level and destroyed edge bonding (left) and glass rebate filled with silicone and first damage on the coating of the IGU (right).

A large proportion of cases of damage in structural glass engineering relate to leaking facades and glass roofs: this is caused by roofs with too low inclination, systems in which the screw connection penetrates the lower sealing level, faulty bonding of the seals, water accumulation in the drainage channel, filling of the glass rebate with silicone, a too small contact pressure and much more. Two examples are shown in Figure 10.
