# Wide span glass roofs: Design - Structural analysis-Errors

Barbara Siebert  
Tobias Herrmann  
Dr. Siebert and Partner Consulting Engineers  
PartGmbH, Munich  
bsi@ing-siebert.de

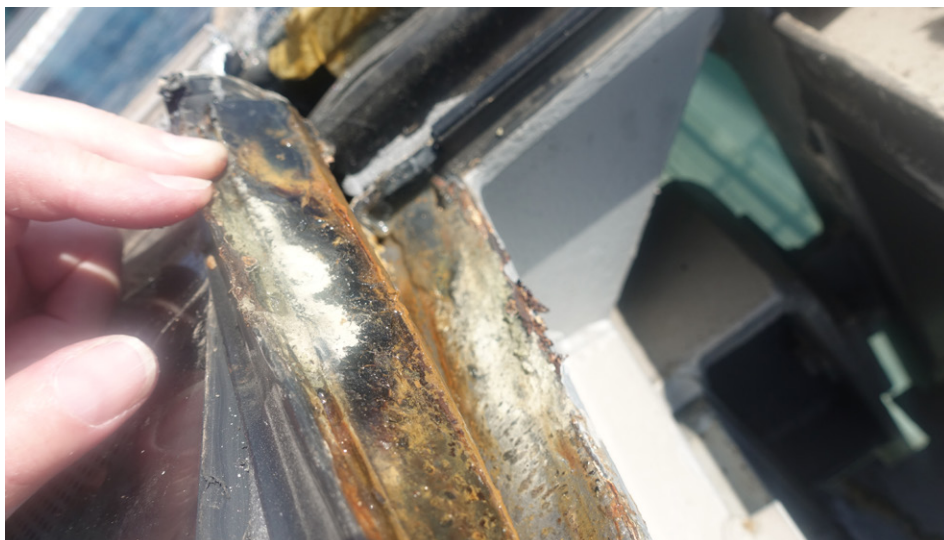
Figure 2: Unbonded crossing point with corresponding leaks and corrosion on the substructure.

glass roofs: this is caused by roofs with too low inclination, transoms that are too wide, systems in which the screw connection penetrates the lower sealing level, faulty bonding of the seals, water accumulation in the drainage channel, filling of the glass rebate with silicone, a too small contact pressure and much more. One example is shown in Figure 2.

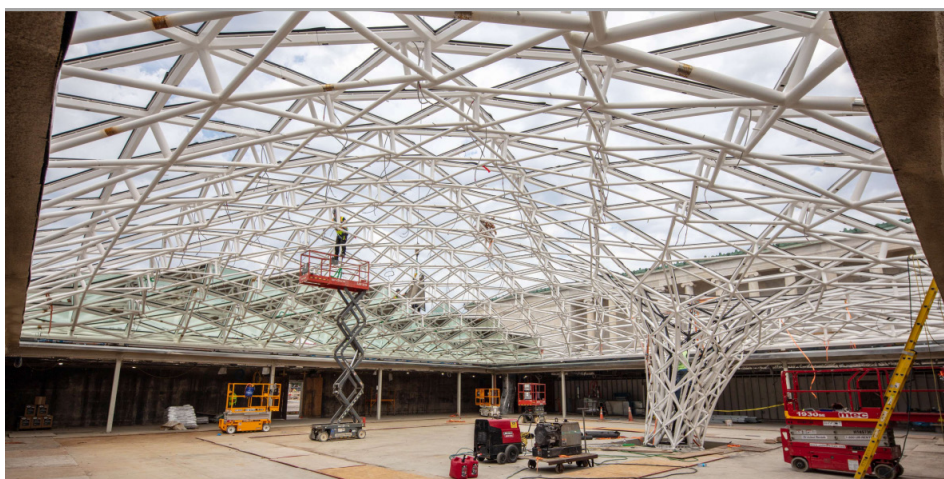
Figure 3: Roof structure during assembly from the inside (© Hahner Technik GmbH & Co. KG).

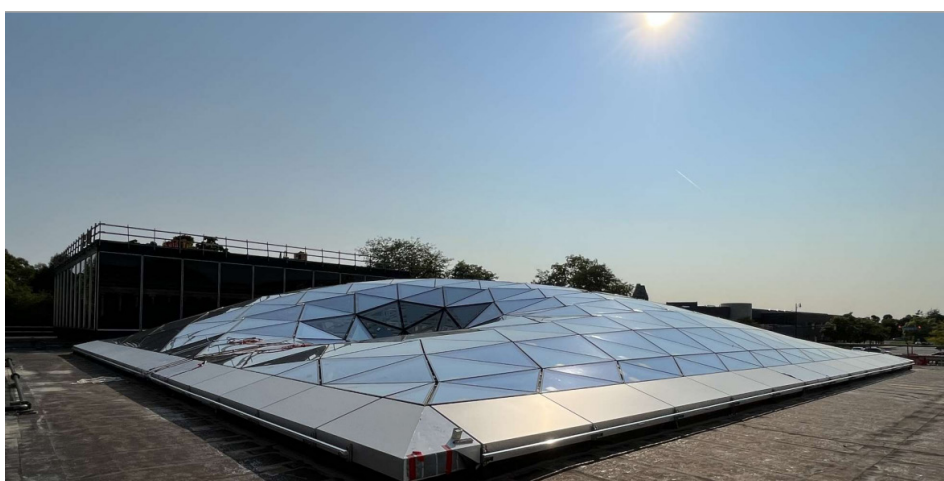
Figure 4: Roof structure from the outside (© Hahner Technik GmbH & Co. KG).
