GLASS PERFORMANCE DAYS 2025

IKEA Valladolid: Reusing an interior all-glass façade

CARLES-HUG BITLLOCH / BELLAPART

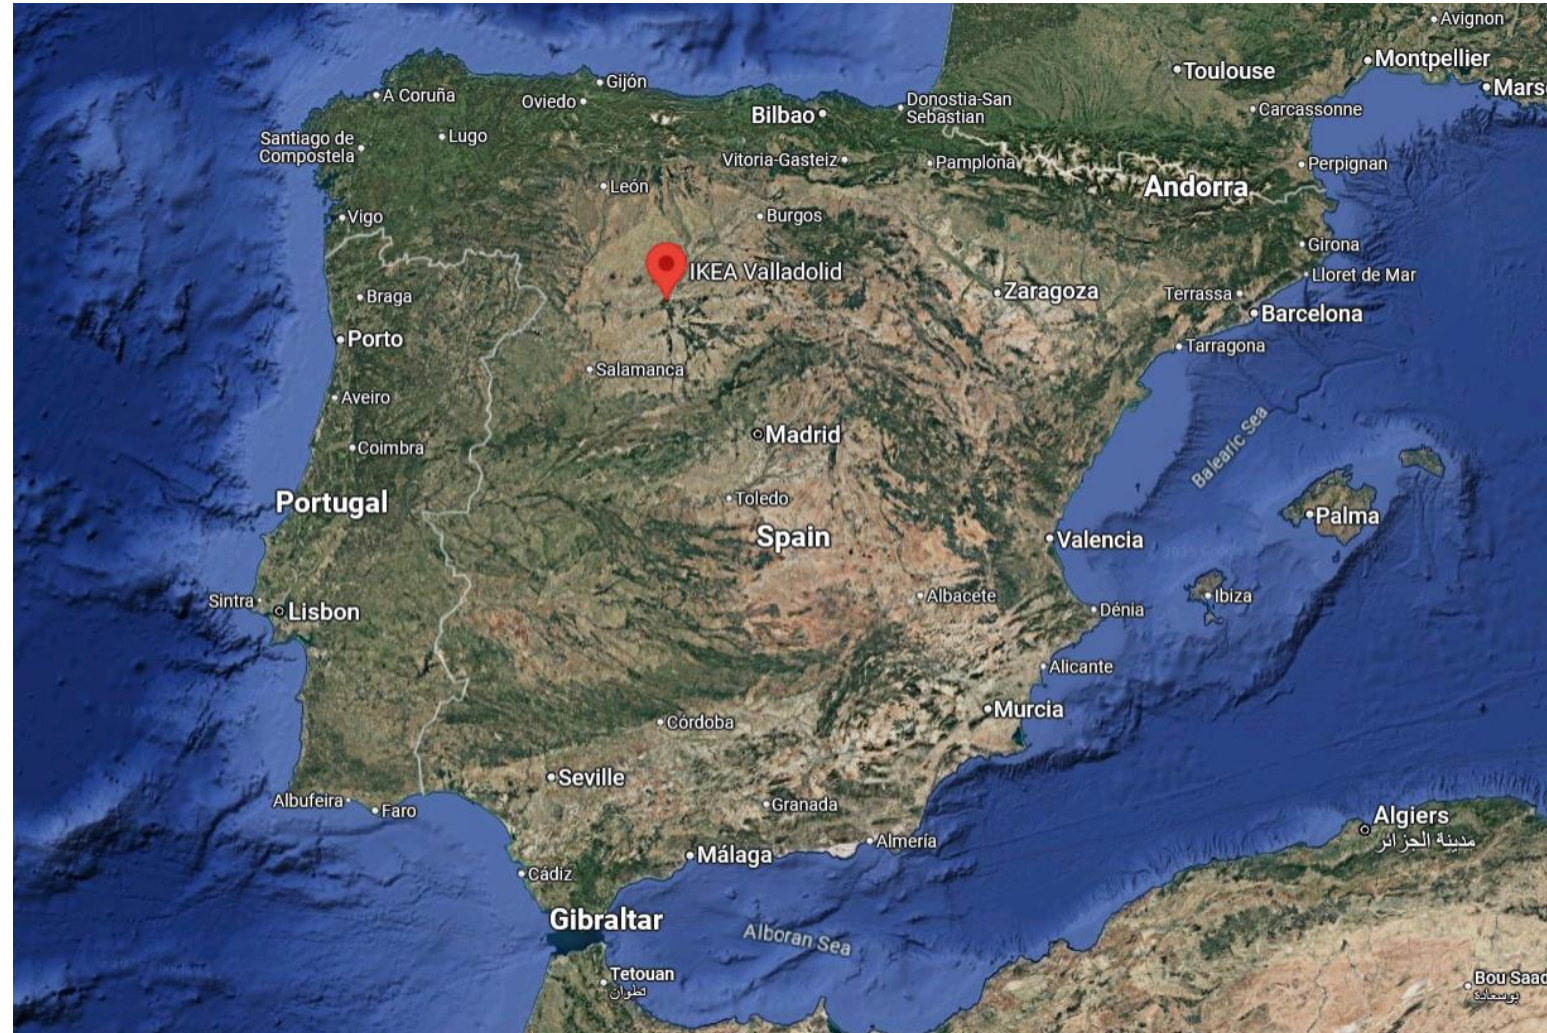
- + Located in central-northern Spain
 - o Shares a building with a mall

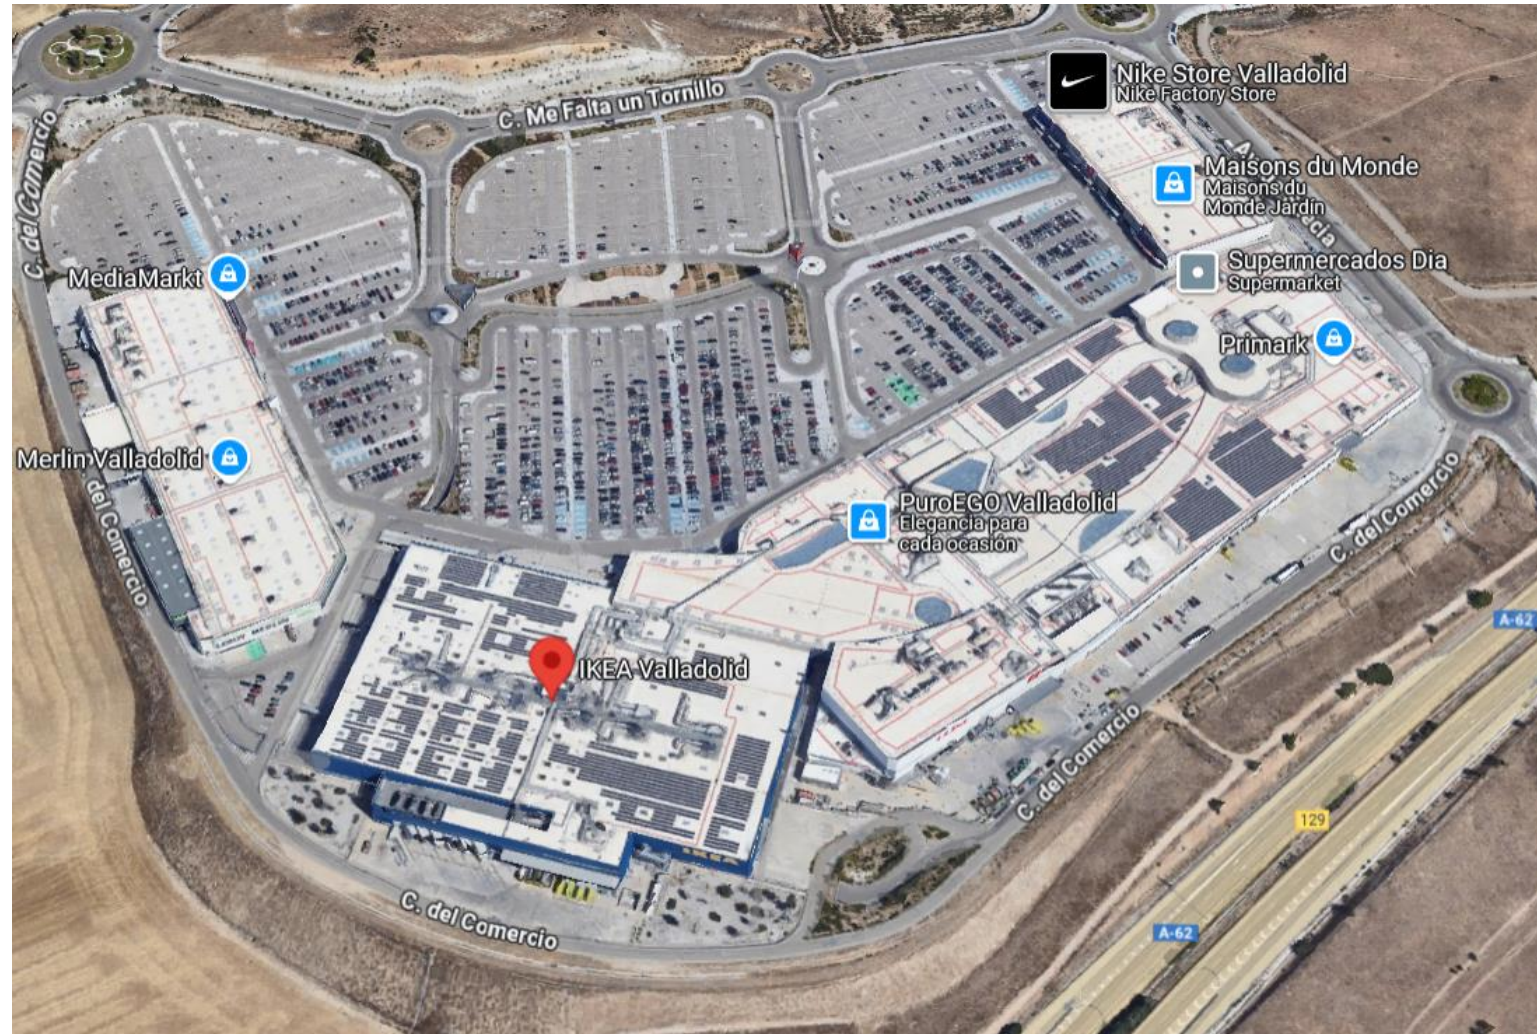
- + Located in central-northern Spain
 - o Shares a building with a mall
- + Major refurbishment in 2022-23
 - o Change of uses in the mall
- + An all-glass façade became obsolete
 - o For location, not materials
- + A third of its glass elements were reused
 - o New façade as relocation

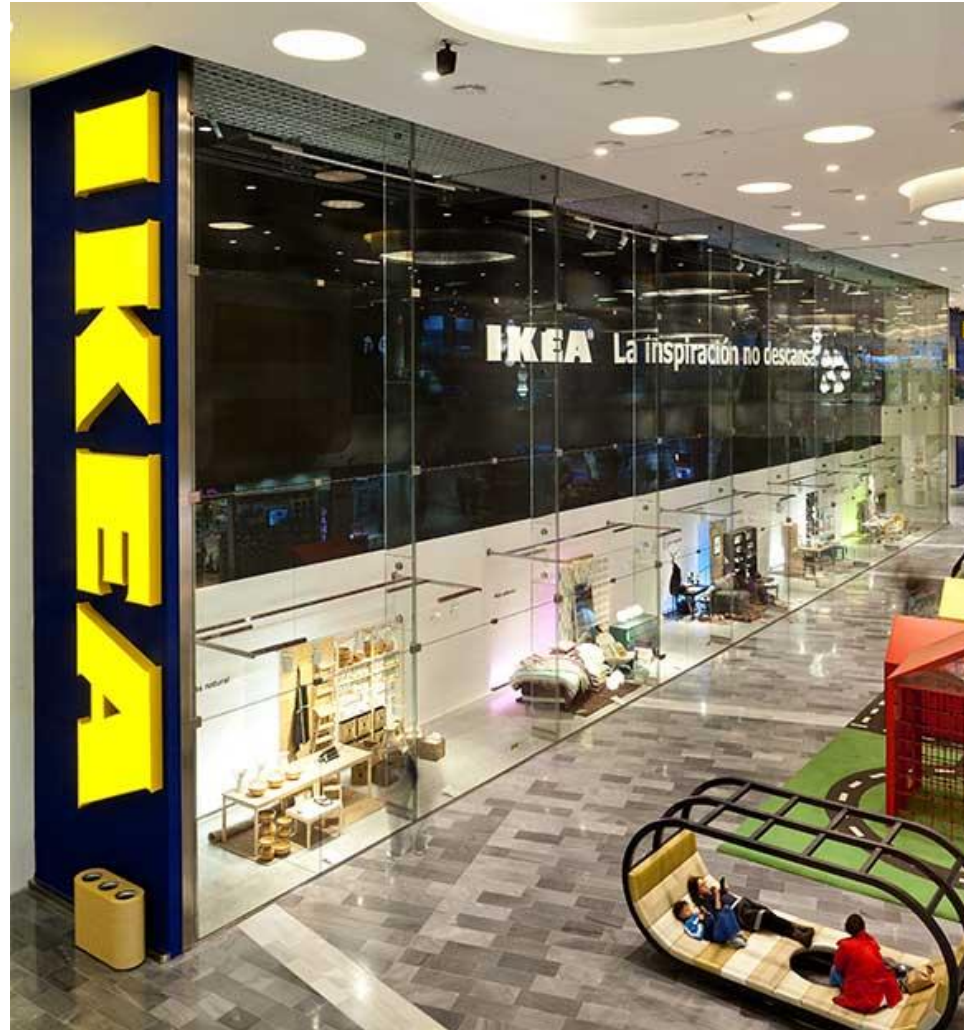
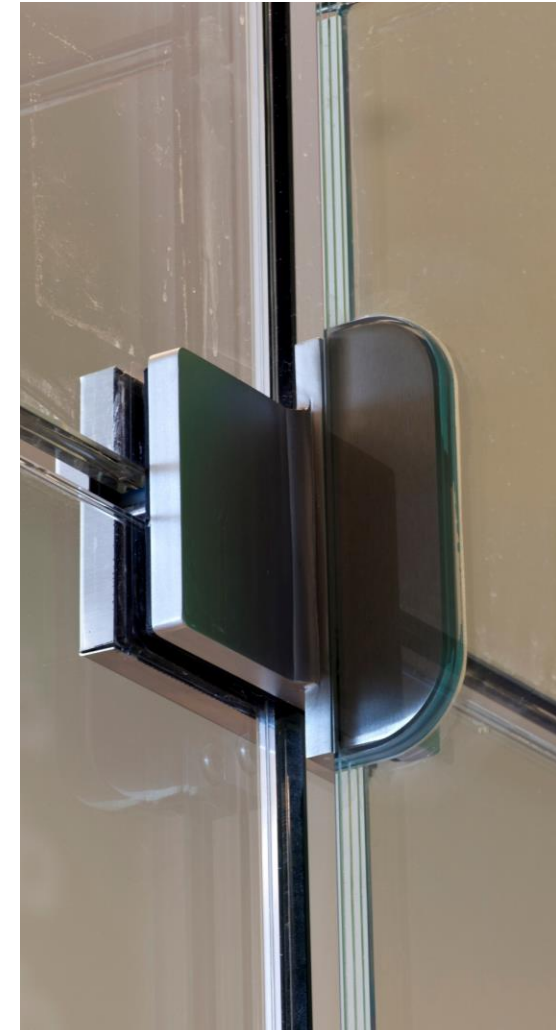
Façade description

- + Designed and built by Bellapart
 - o Original idea by Arup
- + 40m long, 10.6m tall
- + 40 panels (10.10 HS 1.52SG)
 - o 4000x2600mm
- + 9 glass fins (10.10.10.10 FT/HS 1.52SG)
 - o L shaped
 - o 550 wide 10.6m long
 - o Done in four sections
 - o Metallic inserts

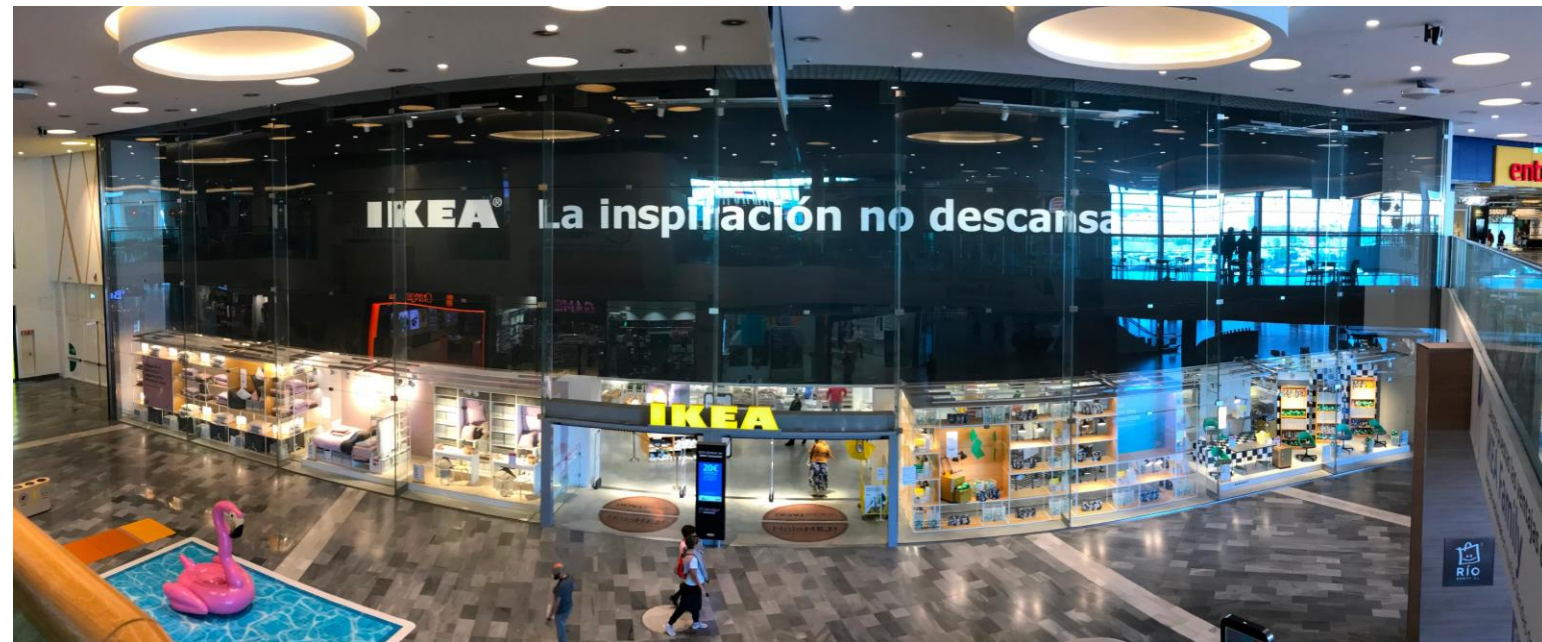
Changes during service time

- + Four panels were retired
- + A door opening was performed
- + Rest of the façade was kept as is (refuse)
 - o Including the fin in the middle

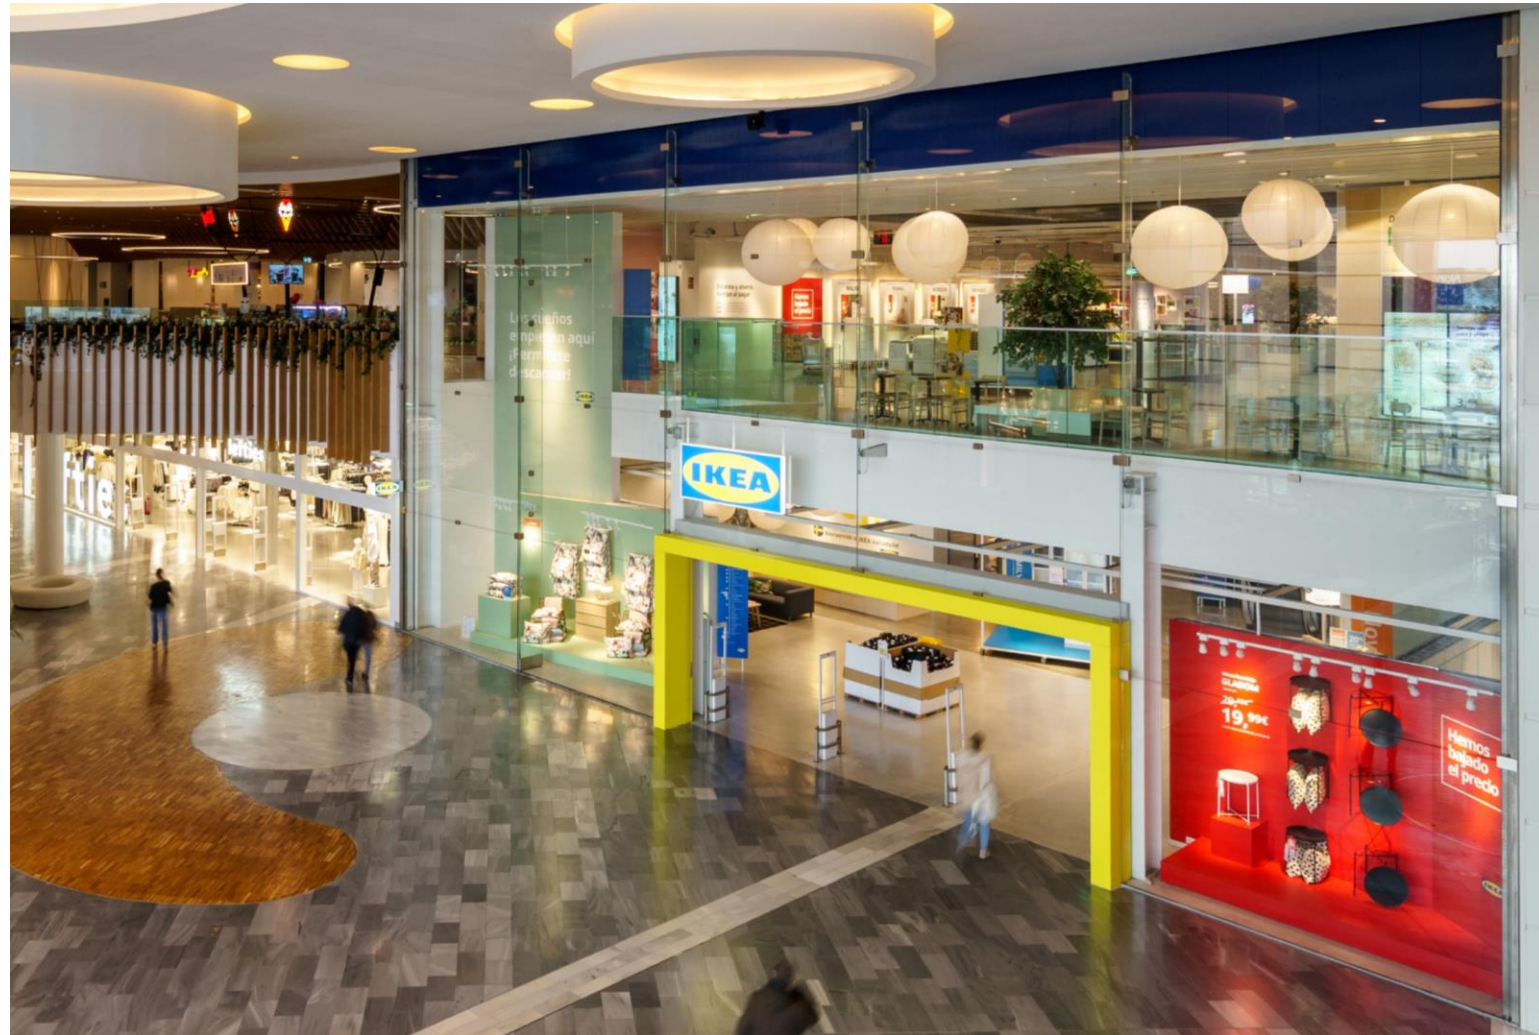
Façade description

- + Designed as a partial relocation
- + 20m long, 10.6m tall
 - o Half of the original
- + 16 reused panels (10.10 HS 1.52SG)
 - o 4000x2600mm
- + 2 new panels (10.10 HS 1.52SG)
 - o 4000x2600mm
- + 3 new glass fins (10.10.10 HS 1.52SG)
 - o 200 wide 5.5m long
- + 1 fin (10.10.10.10 FT/HS 1.52SG)
 - o Meant to be partially salvaged

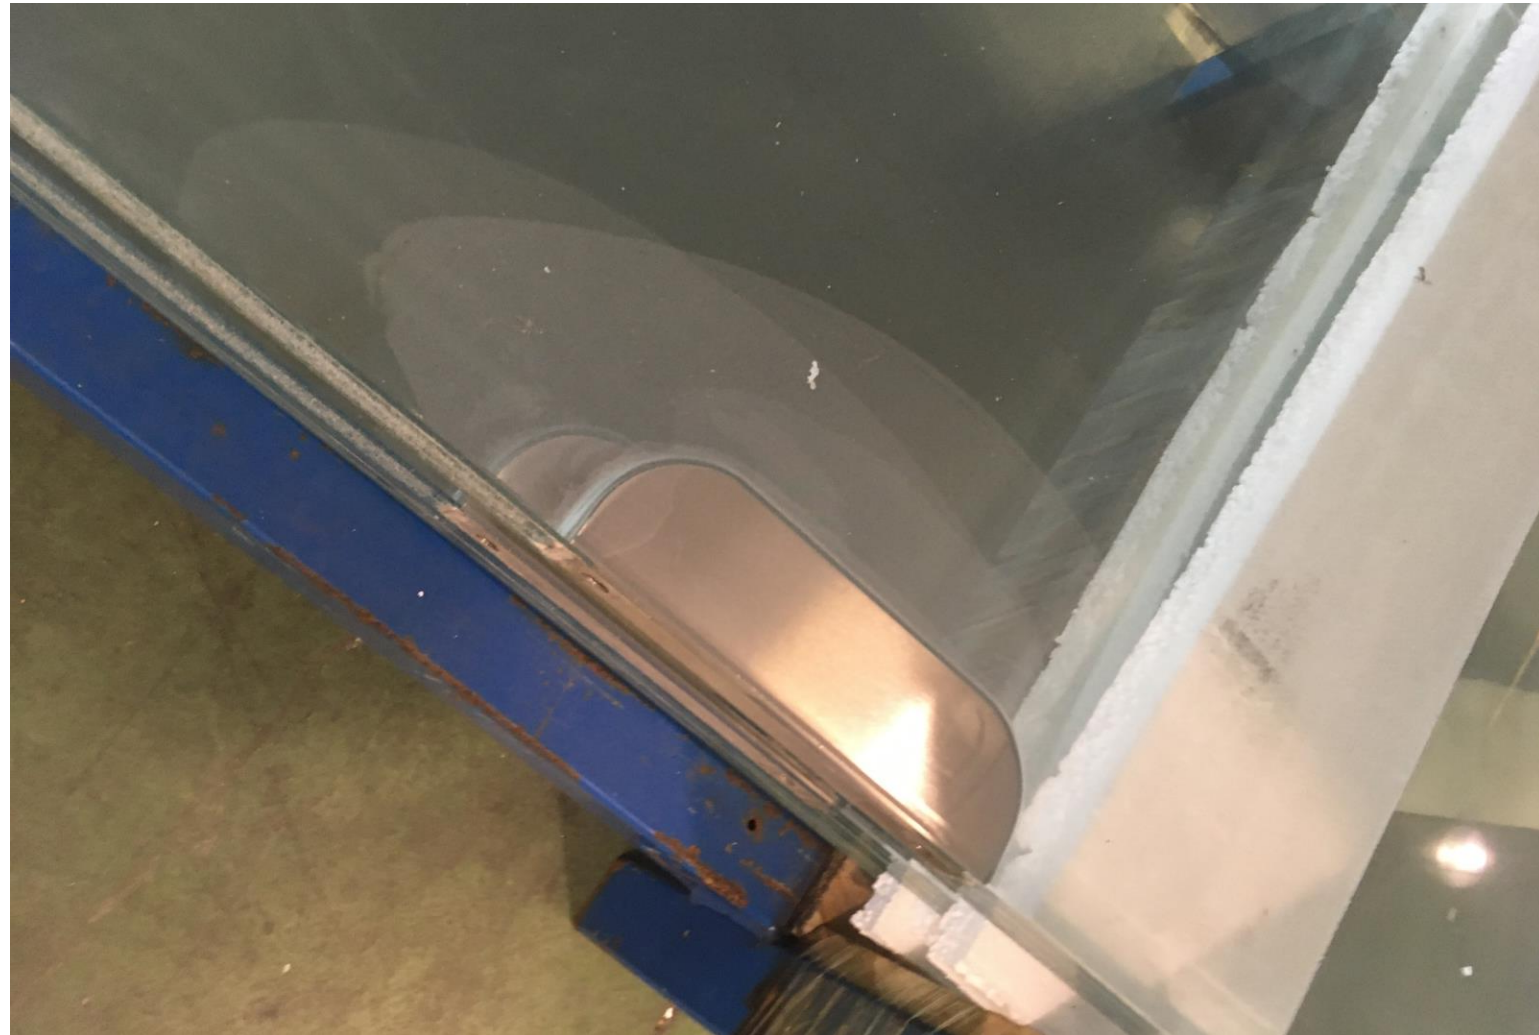
Metallic inserts and delamination

- + Initial thick inserts made of stainless steel
 - o Should be titanium (physical properties)
- + Delamination was localised
 - o Became apparent after transport (715km)
- + Fins were discarded for security issues
 - o Two sections were remade
- + New fins with mechanical fixations

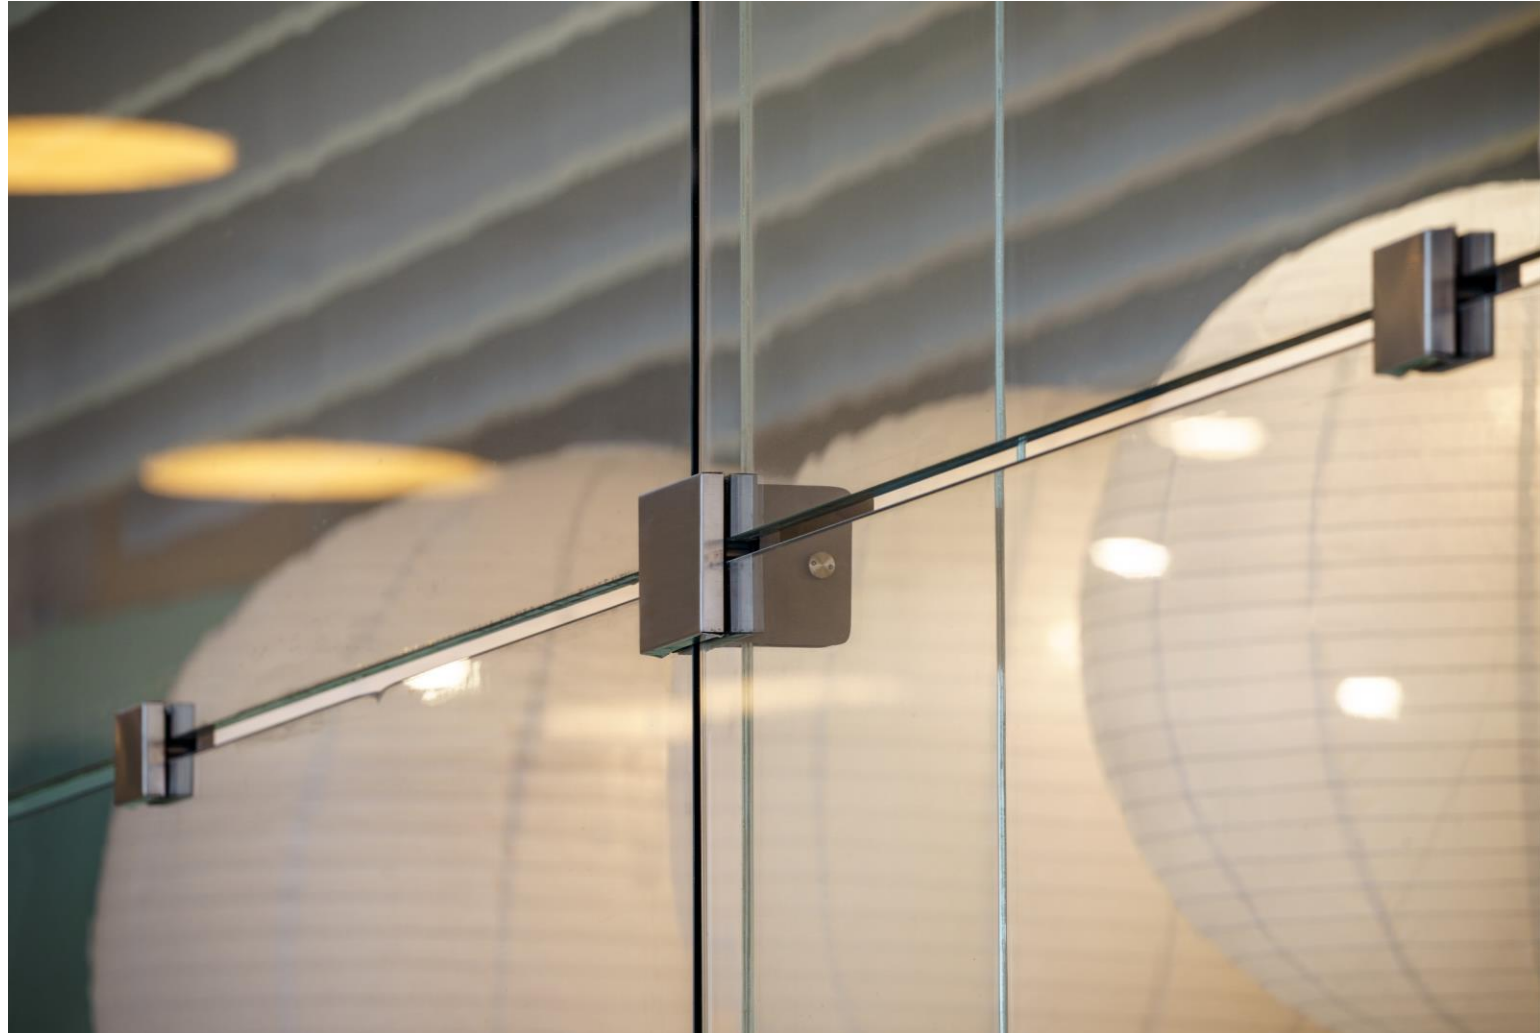
General state of the glass panels

- + No mechanical tests were performed
 - o No guarantee extension was demanded
- + Only visual inspection was made
 - o Inspection in Bellapart (715km road trip)
- + Only best looking panels were selected
 - o Only half were to be salvaged
- + Some aging marks are apparent
 - o Client accepted them

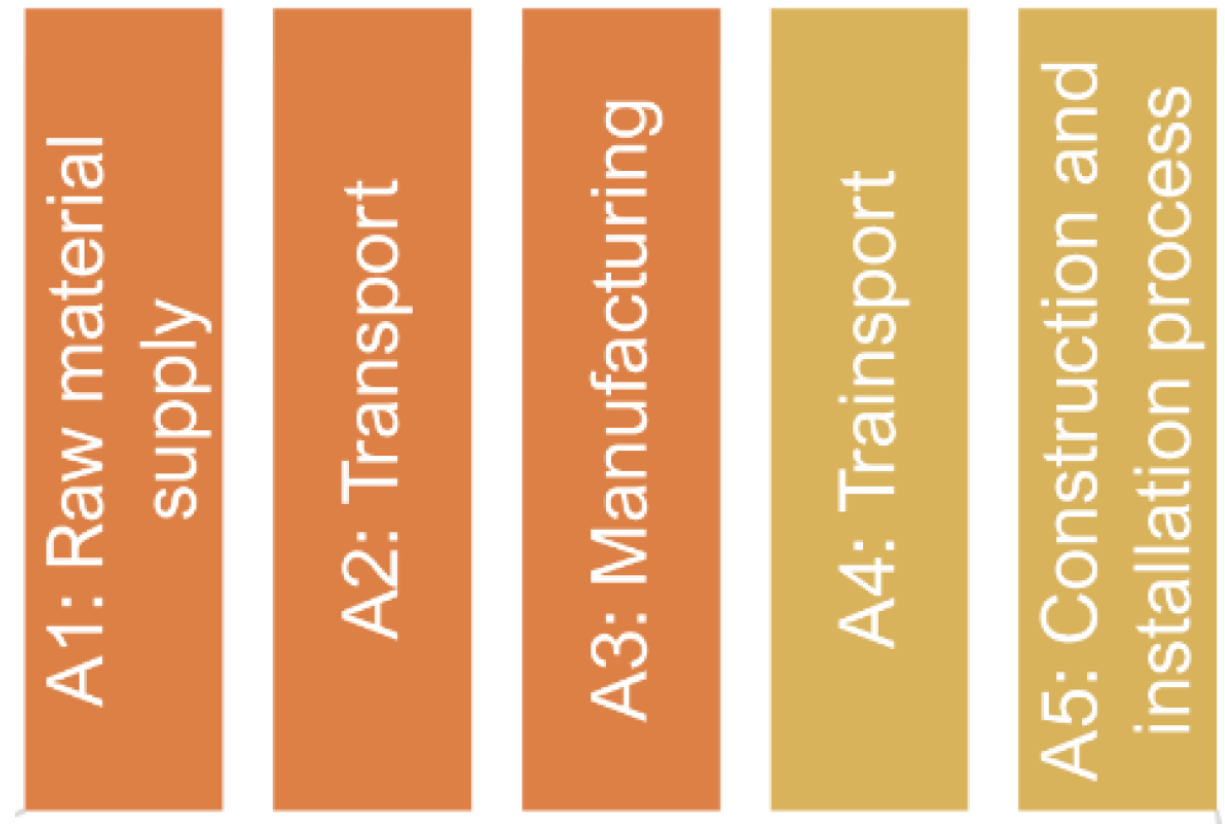
- + Building as a hole: B5 Refurbishment
 - o According to EN 15978
 - o Does not give enough detail
- + Teeuwen et al. approach
 - o Two different buildings: Stages C and A
- + Quantification only in stage A
 - o Bellapart expertise, minimum assumptions

Figure from: Teeuwen, R., Schipper, R., Cupać, J., Jansen, H., & Louter, C. (2024). Circularity of Existing Aluminium Unitised Curtain Wall Façades. Challenging Glass Conference Proceedings, 9.

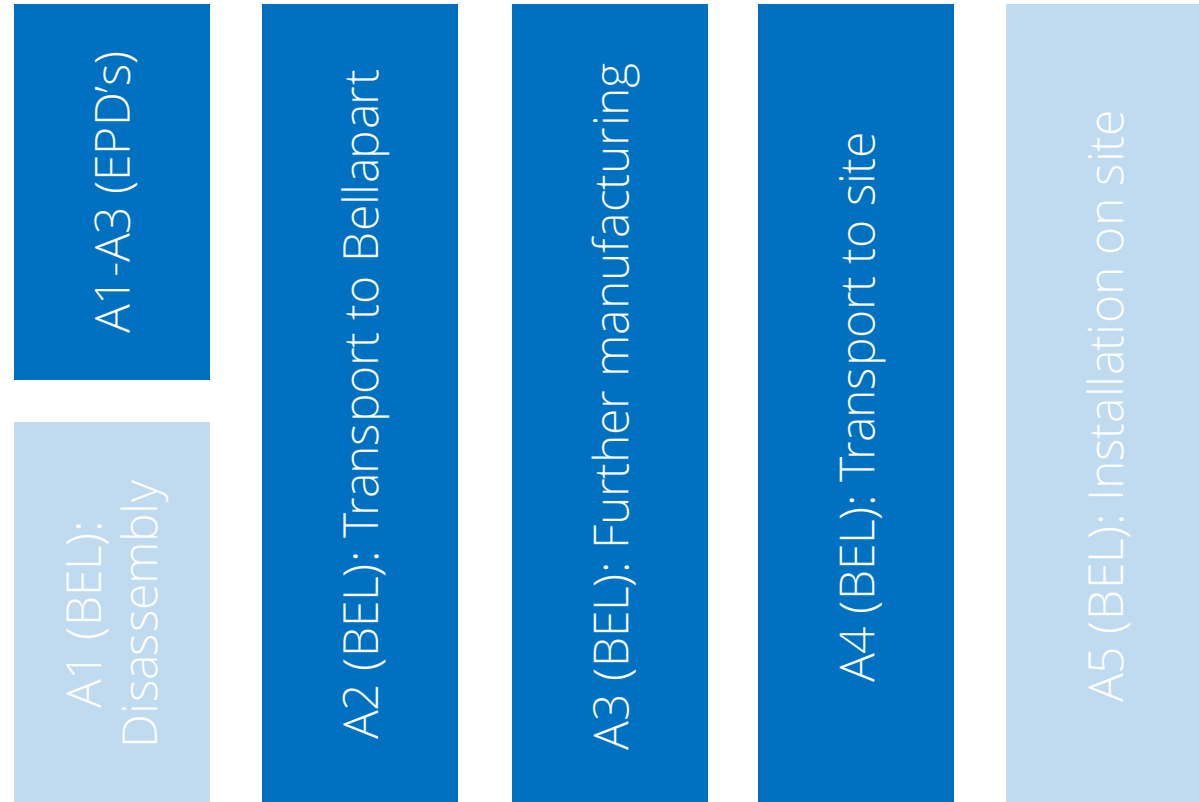
- + Building as a whole: B5 Refurbishment
 - o According to EN 15978
 - o Does not give enough detail
- + Teeuwen et al. approach
 - o Two different buildings: Stages C and A
- + Quantification only in stage A
 - o Bellapart expertise, minimum assumptions
- + Distinction between EPD's and Bellapart
 - o Some of them are null (green energy)

A1-A3 (EPD's)

A1 (BEL):
Disassembly

A2 (BEL): Transport to Bellapart

A3 (BEL): Further manufacturing

A4 (BEL): Transport to site

A5 (BEL): Installation on site

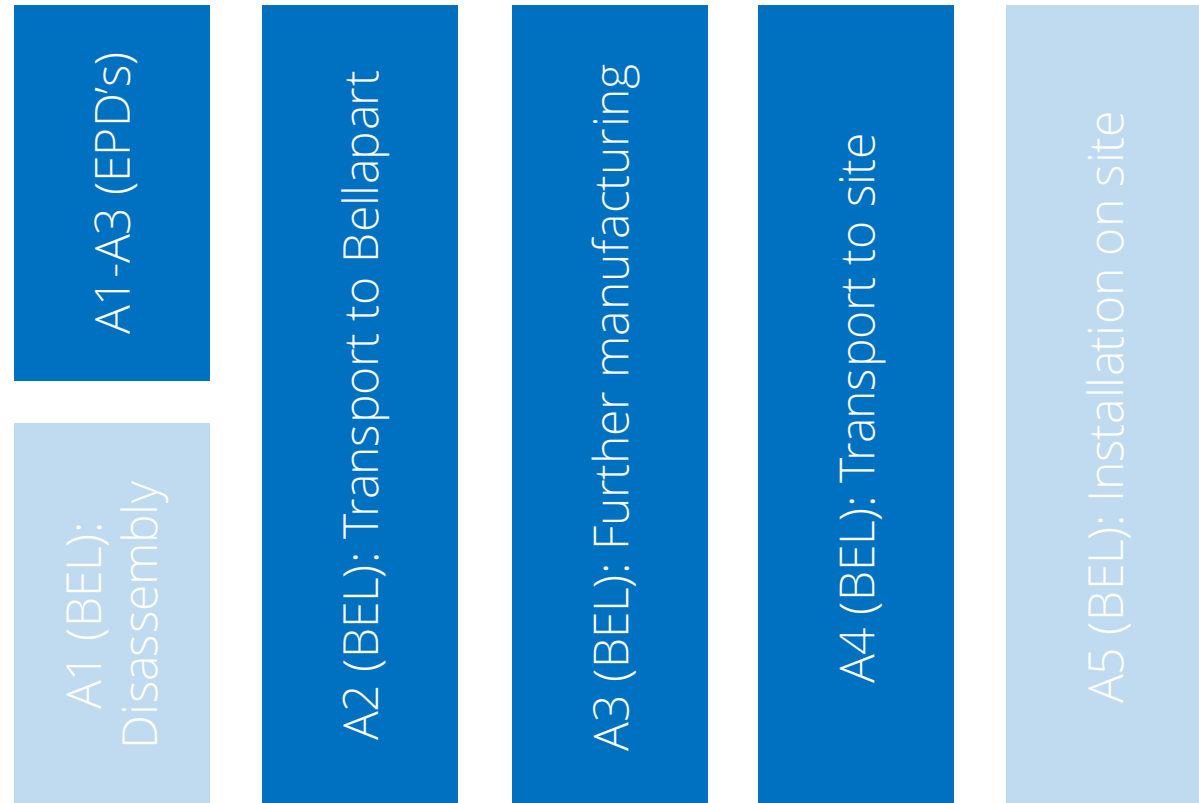
- + Building as a whole: B5 Refurbishment
 - o According to EN 15978
 - o Does not give enough detail
- + Teeuwen et al. approach
 - o Two different buildings: Stages C and A
- + Quantification only in stage A
 - o Bellapart expertise, minimum assumptions
- + Distinction between EPD's and Bellapart
 - o Some of them are null (green energy)
- + Two scenarios considered: reuse and no-reuse
 - o Details declared on the paper

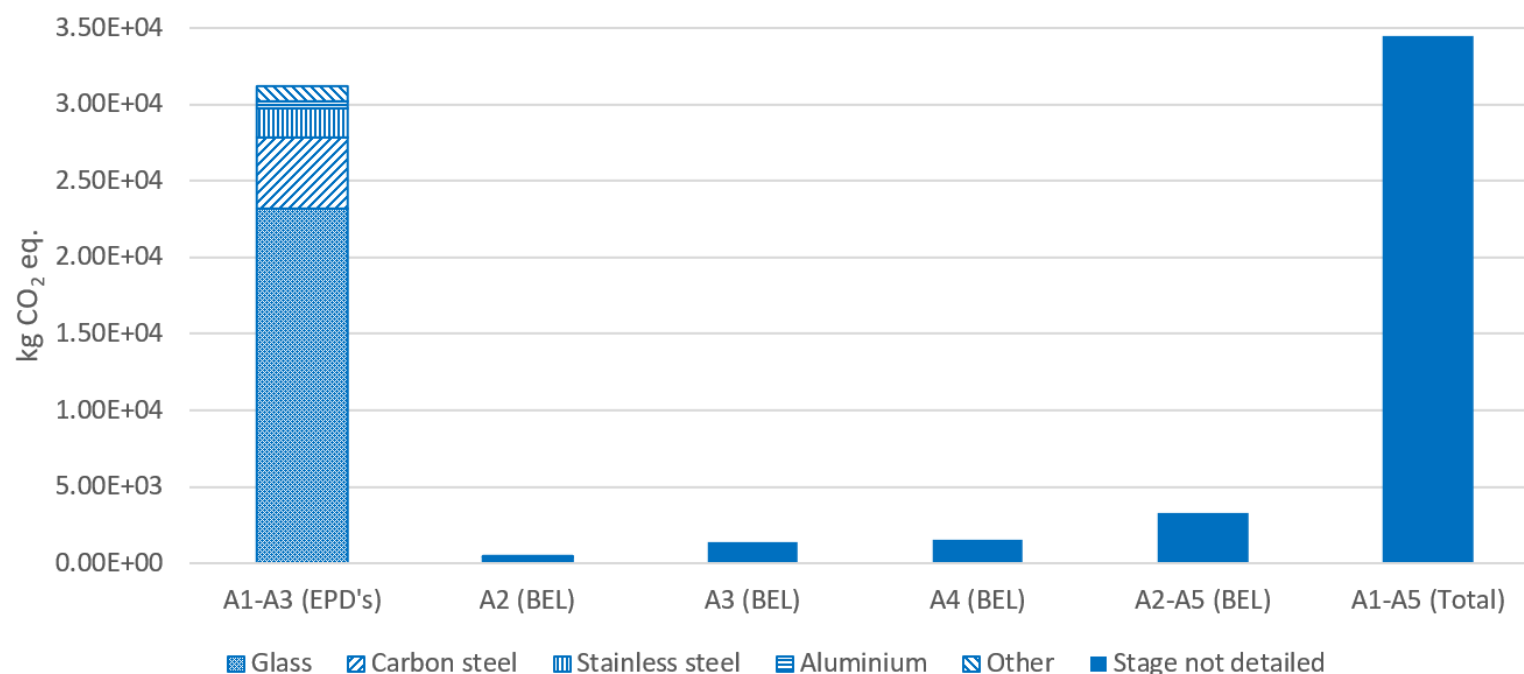
No-reuse scenario

- + Total GWP: 3.45×10^4 kg CO₂ eq.
- + No reused materials
- + A1-A3 (EPD's) is totally dominant
 - o 90% of total GWP
- + A1-A3 (EPD's) of glass is dominant
 - o 74% of A1-A3 (EPD's) GWP
 - o 67% of total GWP
 - o 78% of total weight
- + Not relevant module A2 (BEL)
 - o 1% of total GWP
 - o All transport non-dedicated
