Glazing The Met: A Case Study in Design Considerations for Museum Glazing

Kateri Knapp

Arup, USA kateri.knapp@arup.com

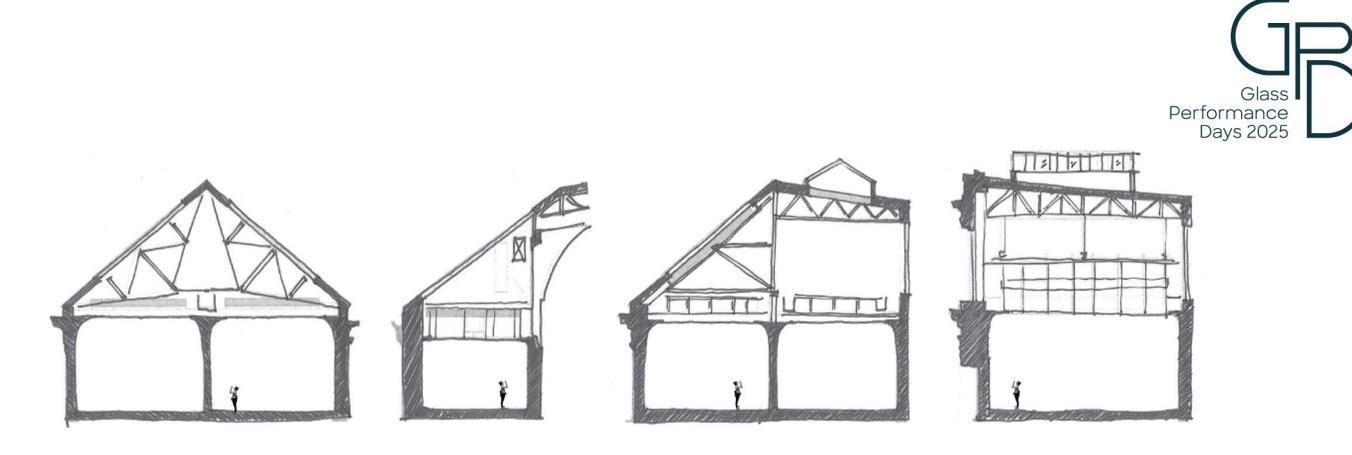
As is a common architectural configuration for museums of the late 1800's and early 1900's which rely on natural daylight for their galleries, the ABC Wings feature glass "laylight" ceilings which separate the patron experience of the gallery from the attic space and true building envelope above. The laylights conceal a back-of-house plenum which was originally intended to serve as a daylight mixing chamber including adjustable fabric louvers, and to provide a level of separation between the polished architectural space of the gallery and the back-of-house view of the building structure and skylight system. As mechanical systems and electric lighting were introduced, the attics' function expanded to hide the growing MEP services above the laylight grids.

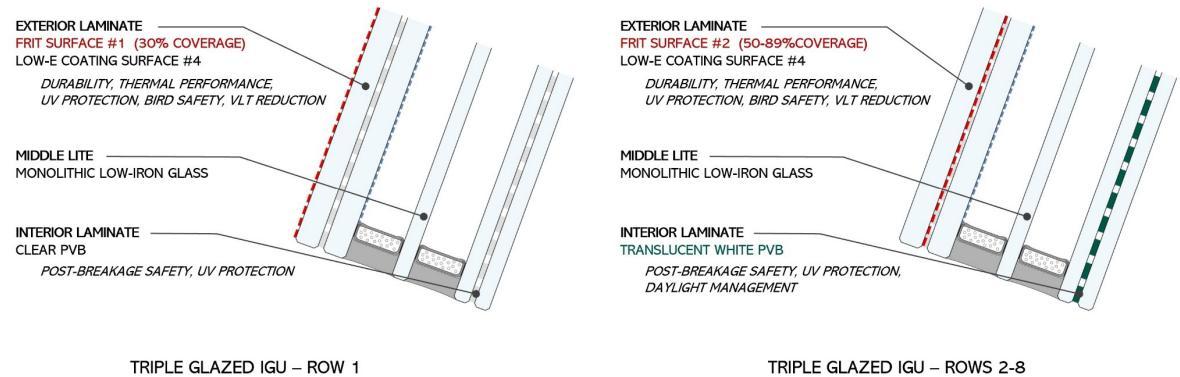
To maintain maximum visual transparency and views of the park through Row 1, the selection of a low-E coating that optimizes reduction of VLT while maintaining all other performance criteria was particularly challenging as many coatings achieve a low VLT and high CRI by increasing exterior visible reflectance, which negatively affects bird safety performance. This was a critical consideration for the MCR Wing due to its prominence within Central Park. Even with an exterior visible reflectance below the 15% threshold, qualitative review of glazing samples by the American Bird Conservancy at the 20 degree incline towards the sky resulted in a need to move the frit for Row 1 to surface #1 to improve the visual deterrent effect of the frit pattern. Ultimately, GlasTroesch's CombiSilver 32/21 T provided the most successful balance of all performance criteria and avoided excessive Row 1 frit coverage and/or the addition of tinted substrates to further reduce VLT and achieve the 20% target.
